APPENDIX D
Protected Tree Report

Protected Tree Report

Conejo Creek Park Southwest Development Project

PROTECTED TREE REPORT

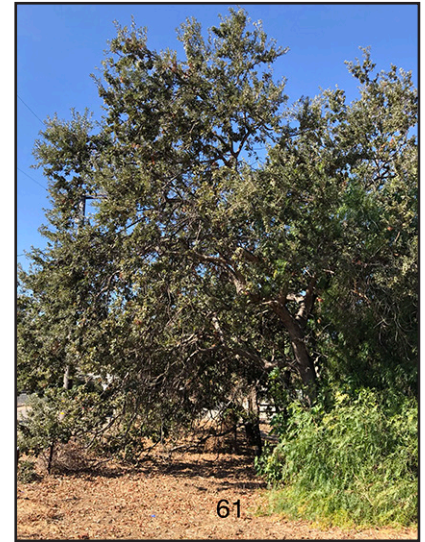
Tree 61

Tree #	Species	Trunk Diameter (in.)	Health Rating	Reason for Disturbance
61	Jc	16 trunks each measuring between 4 - 6 inches	B	Ground plane improvements associated with a native earth equestrian trail and project grading activities. No grading activities or changes to the existing grade are anticipated.
62	Ql	6.7, 8.3	C	Minor grading activities to daylight into the existing grade as well as ground plane improvements associated with a native earth equestrian trail and project grading activities. No changes to the existing grade are anticipated.
71	Jc	6.4, 6.7, 7.6, 4.8, 4.8	C	Ground plane improvements associated with a native earth equestrian trail and project grading activities. No grading activities or changes to the existing grade are anticipated.
72	Jc	6 trunks each measuring between 9.5 - 13.4 inches	B	Ground plane improvements associated with a native earth equestrian trail and project grading activities. No grading activities or changes to the existing grade are anticipated.

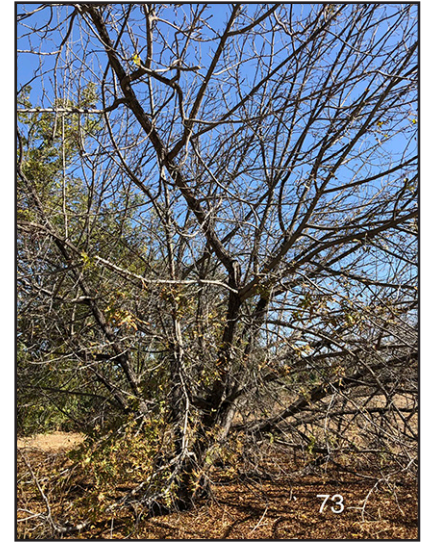
Tree 73

Tree #	Species	Trunk Diameter (in.)	Health Rating	Reason for Disturbance
73	Jc	10 trunks each measuring between 4.8 - 9.5 inches	C	Ground plane improvements associated with a native earth equestrian trail and project grading activities. No grading activities or changes to the existing grade are anticipated.
237	Ql	30.9	B	Grading and construction activities associated with a native earth equestrian trail and an asphalt pedestrian path. No changes to the existing grade are anticipated.
239	Qa	20.7	B	Grading and construction activities associated with an asphalt pedestrian path.
241	Qa	7.6	C	Grading and construction activities associated with the proposed sand volleyball court.
245	Qa	5.4	B	Construction activities associated with the placement of a two-rail fence along Paige Lane.
246	Qa	8.6	B	Construction activities associated with the placement of potentially two (2) footings associated with the two-rail fence proposed along the southern edge of Paige Lane.

-
- 1) Soil levels within the PZ shall be maintained at natural grade within the PZ of Tree #s 71 – 73, 237, 239, 241, 245, 246, 248, 254, and 255.
 - 2) Approved pruning of deadwood, broken branches and recommended structural pruning in accordance with International Society of Arboriculture, Pruning Standards and ANSI A-300 Pruning Guidelines.

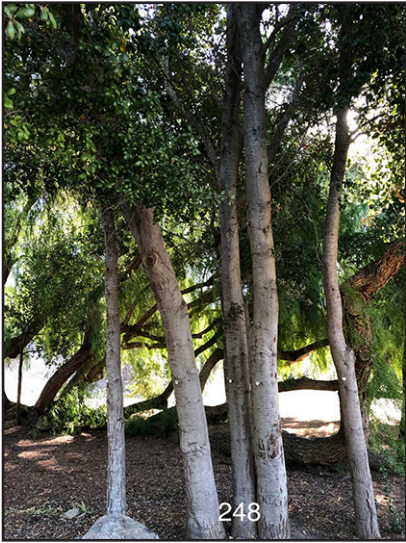
Tree 248

248	Qa	7.3	C	Construction activities associated with the placement of a two-rail fence along Paige Lane.
254	Qa	3.2	B	Construction activities associated with the placement of potentially three (3) footings associated with the two-rail fence proposed along the southern edge of Paige Lane.
255	Qa	3.5	B	Construction activities associated with the placement of a two-rail fence along Paige Lane.
